# This is why you should not "TRUST THE TRUSS"

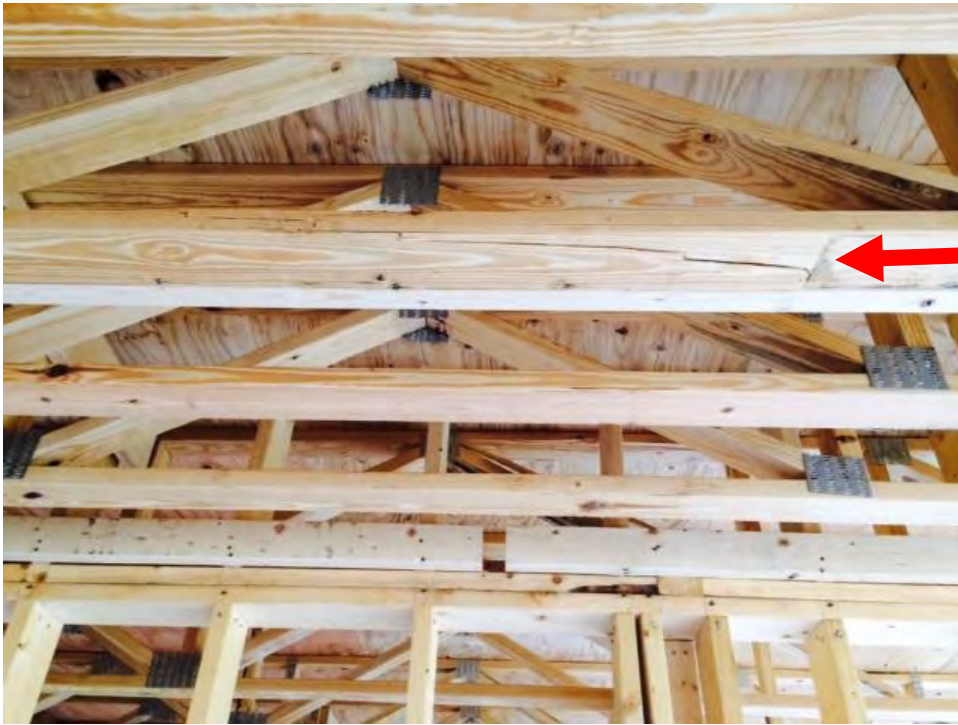
The Bottom chord of the Truss is cracked.  
It appears that the contractor tried to sister an 8Ft. 2"x4" to the side of the bottom chord.

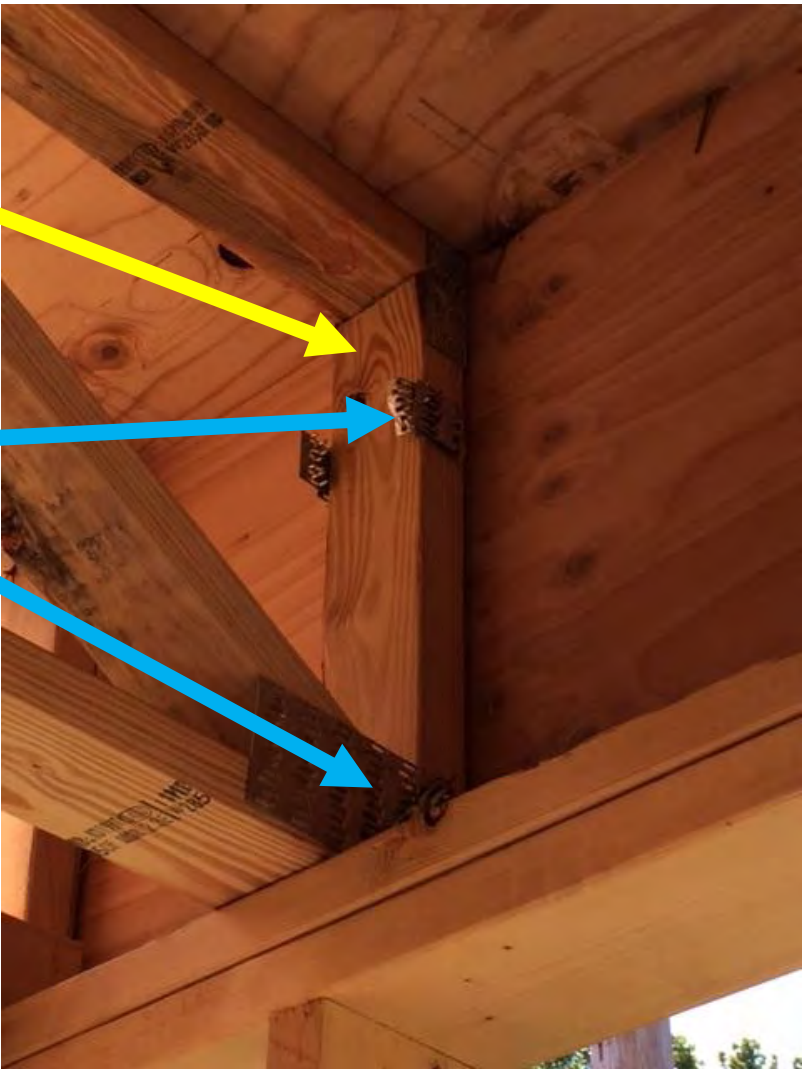
The end of this Truss was greatly modified upon installation, the second outer vertical member was completely removed from the Truss.

The Gusset Plates were bent backwards.

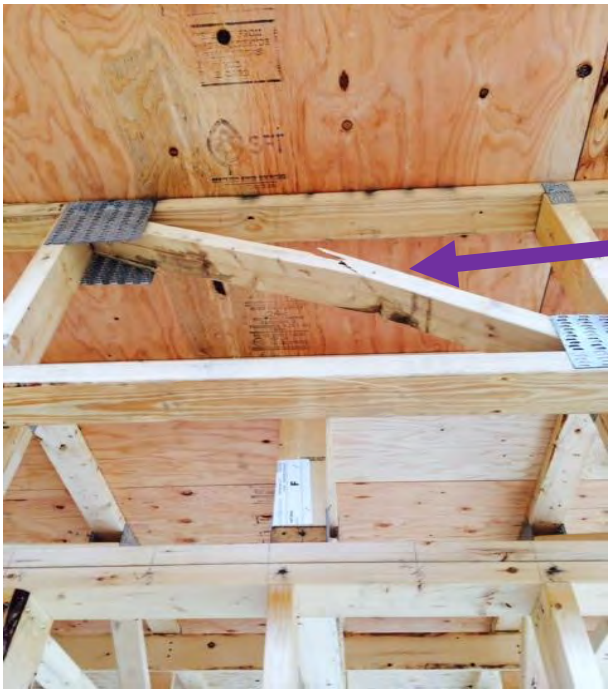
Broken Web member

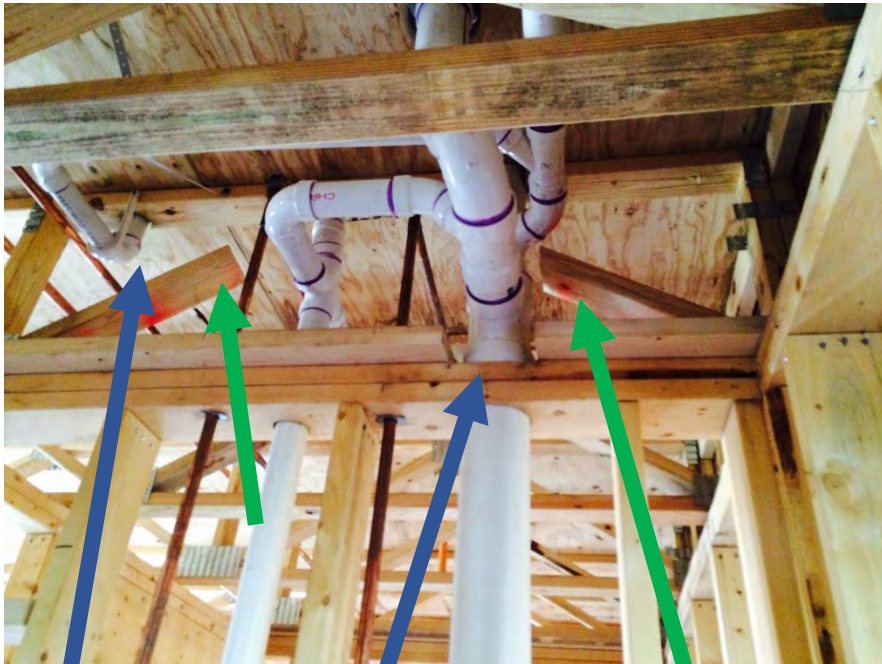
A plumber destroyed this truss by removing structural members and making numerous penetrations to the Top & Bottom Chord.

Penetrations through the Top & Bottom Chord

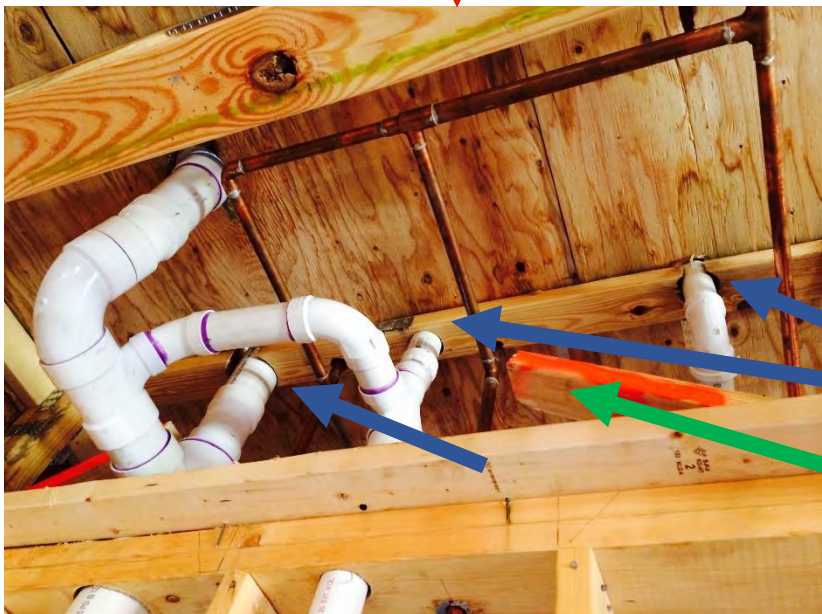
Webbing Members & Gusset plates removed
